Ashoka Trust for Research in
Ecology and the Environment

Report on estimation of inflows into Bellandur Lake

Veena Srinivasan
Priyanka Jamwal
Sayan Roy
Praveen Urs
Chandan Gowda

May 2017

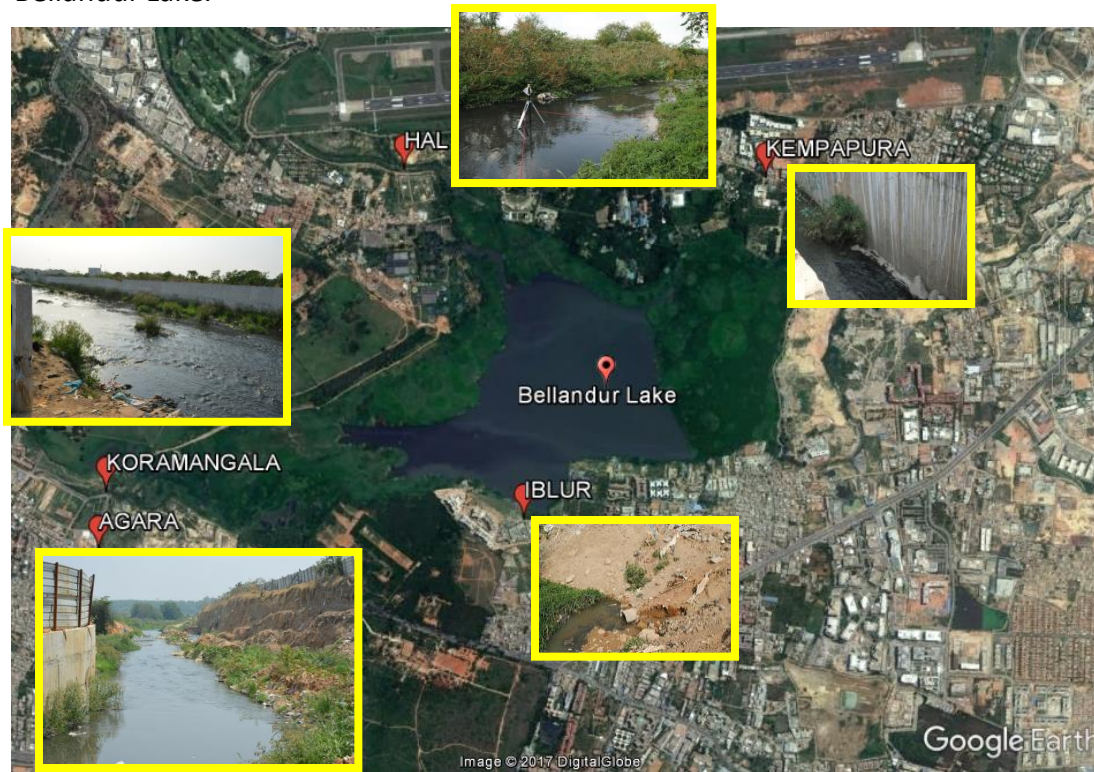
Figure 2: Map of major inlets into Bellandur Lake

At present there are three major inlets and two minor inlets through which sewage enters Bellandur Lake.

Description of the inlets:

Koramangala Storm Water Drain: This swd is a wide channel (23m close to lake entry where stage was measured). It passes through Ejjipura and Koramangala carrying raw sewage from the different wards present in these areas. The channel carries a lot of floating debris and solid waste. There is high sedimentation due to the organic matter.

Agara Storm Water Drain: The Agara drain has connectivity upstream from the Agara lake which was currently dry and being rejuvenated/de-silted . The drain crosses Sarjapur road via a culvert and makes a few turns before entering Bellandur. The section which was monitored had high flow velocities as the channel was constrained. Upstream of the monitoring point, 30 MLD of untreated wastewater is lifted by the BWSSB Agara pump house.

HAL Storm Water Drain: This is a relatively shallow and moderately narrow stream that joins Bellandur lake after crossing Murugesha Palya and HAL airport after which it joins another minor drain and enters the lake.

Iblur Drain : The open channel has been blocked off with soil, next to this lies a relatively small circular conduit carrying wastewater from the Iblur village and surrounding layouts.

Kempapura Drain: This is an open rectangular vegetated channel with shallow flows from Kempapura side

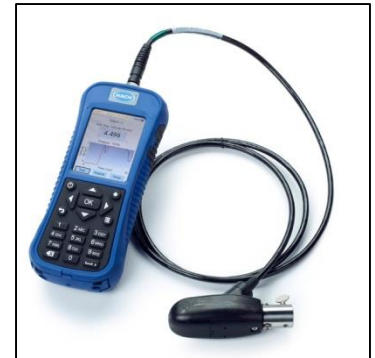
Photo : HACH velocity meter

The drains were profiled and velocity measurements were taken at 0.5 m intervals. Velocity was measured using a HACH velocity flow meter at a depth of 0.4 times the water stage. Stage was measured using an Odyssey Capacitance Sensor. Stage was recorded continuously for about a day at 10 minute logging intervals. The capacitance instrument was placed in a perforated pipe and mounted on a tripod in the stream. The sensors were calibrated prior to installation at each location.

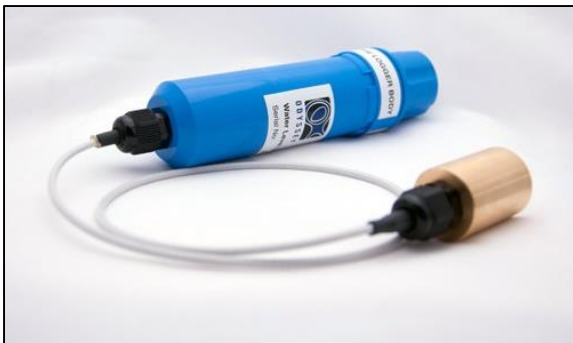
Photo : Odyssey Capacitance Sensor

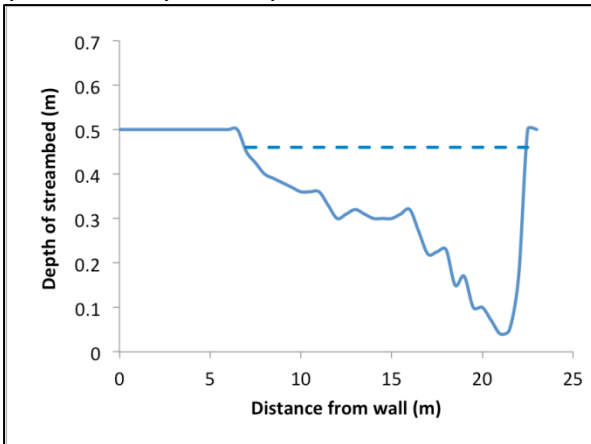
Figure 6: A). Stream Profile B) 24-hour stage and C) Discharge.

The stage, installed at 17.5m in the profile, did not vary much through the day (barely a 5 cm change through the day) although there was a slight dip in the night and late afternoon.

The stream was found to have a continuous sewage flow of approximately 83 MLD.

The measurements were done at 12.92931° N 77.64186° E. This point was accessed from turning off from the Intermediate ring road towards Jakkasandra extension. The stream was approximately 23 m wide and water depth averaged about 25 cm. The continuous monitoring of stage occurred from 4-May, 2:50 pm to 5-May, 16:40 pm.

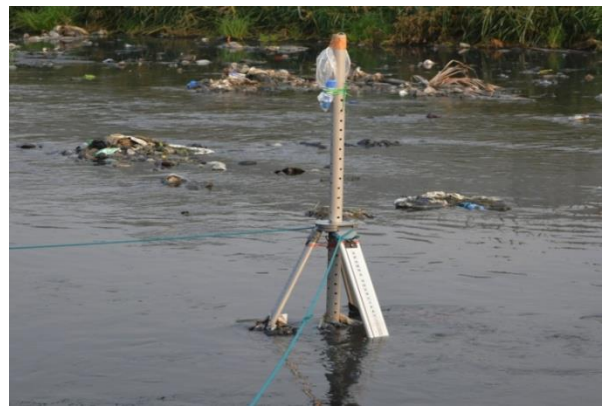
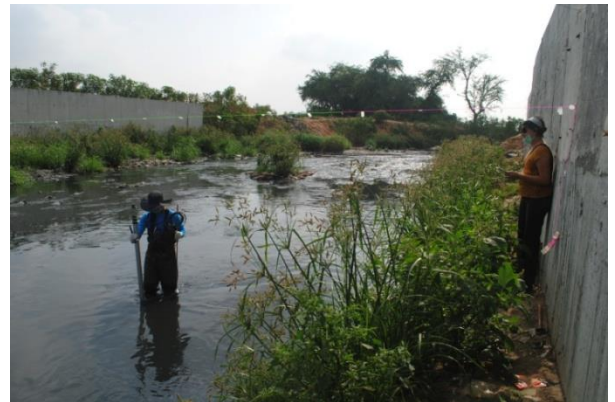
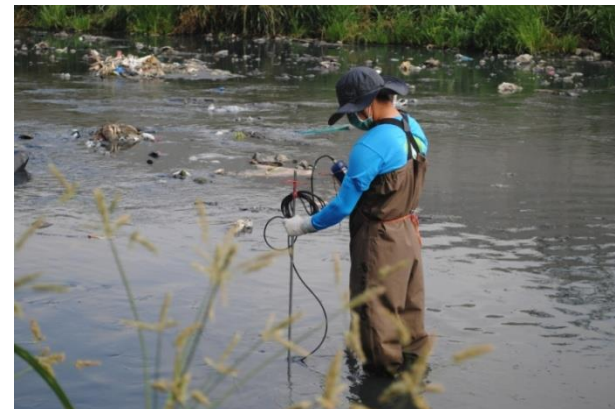
Figure 5: A) 24h Stage monitoring B) Profile measurement C) Velocity measurement

Field work at Koramangala Drain on 5 and 6 May 2017

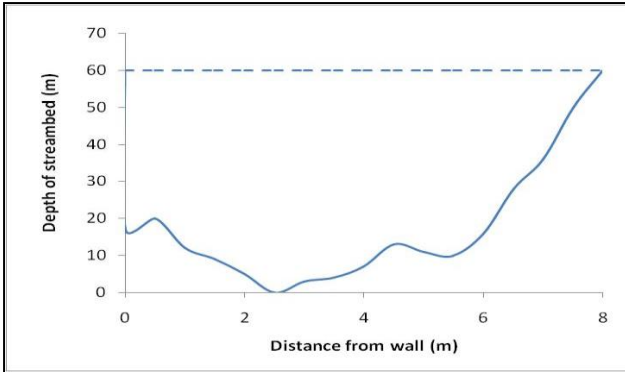
Figure x: A). Stream Profile B) 24-hour stage and C) Discharge.

The stage, installed at x=6 m in the profile, dropped significantly by 10-15 cm during the hours of the night, the sizeable drop can be attributed to narrow channel width. The average stage was found to be 44 cm.

The stream was found to have a continuous sewage flow of approximately 6 million litres per hour or **140 million liters per day.**

The measurements were done at 12.92634° N and 77.64147° E. This point was accessed from Sarjapur main road side. The stream was approximately 8 m wide and water depth averaged about 45 cm during stream profiling.

The continuous monitoring of stage occurred from 5-May, 6:30 pm to 6-May, 4:10 pm.

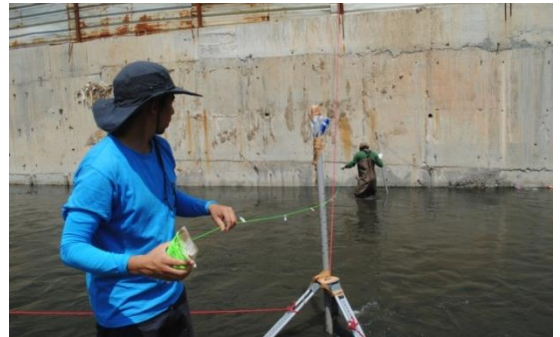
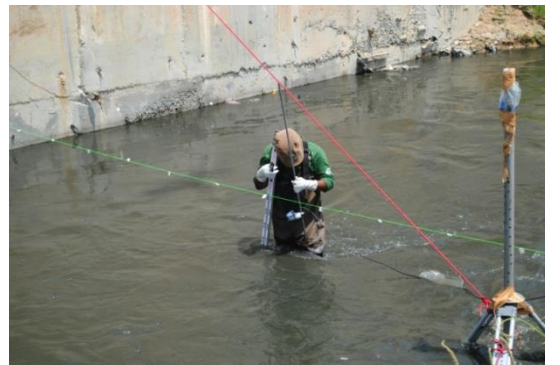
Figure y: A) 24h Stage monitoring B) Profile measurement C) Velocity measurement

Field work at Agara Drain on 5 and 6 May 2017

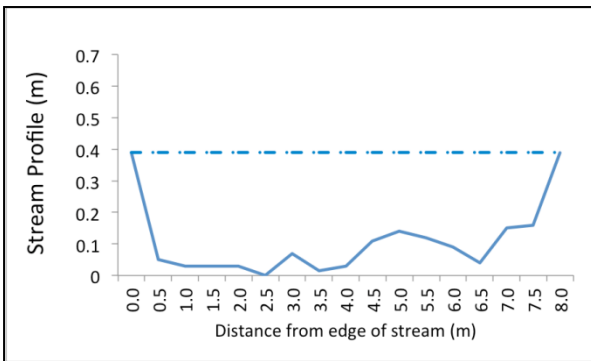
Figure x: A). Stream Profile B) 24-hour stage and C) Discharge.

The stage, installed at x=4.25m, did not vary much through the day (barely a 5 cm change through the day) although there was a slight dip in the night and late afternoon.

The stream was found to have a continuous sewage flow of approximately 1.5 ML per hour or **36 MLD**.

The measurements were done at 12.94563° N and 77.65738° E. This point was accessed from turning left before Chelaghatta STP and going through Belur Nagsandra village. The stream was approximately 8 m wide and water depth averaged about 11 cm.

The continuous monitoring of stage occurred from 5-May, 2:50 pm to 6-May, 2:10 pm.

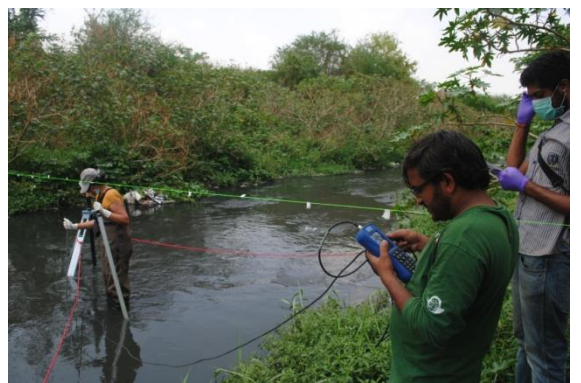
Figure y: A) 24h Stage monitoring B) Profile measurement C) Velocity measurement

Field work at HAL Drain on 5 and 6 May 2017

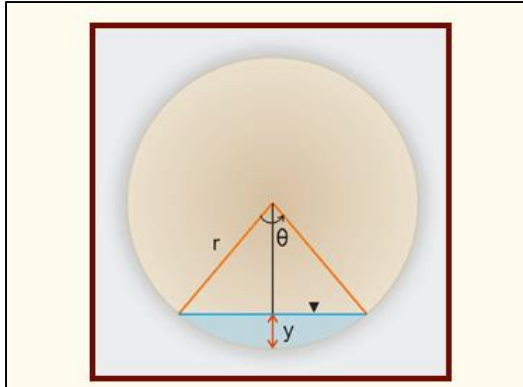
Iblur drain had two inlets: the first was a pipe bringing sewage from a nearby set of apartment complexes. The second was a SWD that was heavily silted and vegetated. In both cases, the cross sectional area of a circular drain, partially filled with water was estimated.

Formulas
$\theta = 2 \cos^{-1}[1 - 2(y/D)]$
$A = (D^2/8) (\theta - \sin\theta)$
$P = r\theta$
$R = A/P$
$Q = (k/n) AR^{2/3}S^{1/2}$
$v = Q/A$

Type	Pipe flow (partial)
Velocity method	Float
Diameter	0.3 m
Stage	0.1 m
Variation	0.01 m

Type	Open Channel flow
Channel diameter	1 m
Stage	0.22 m

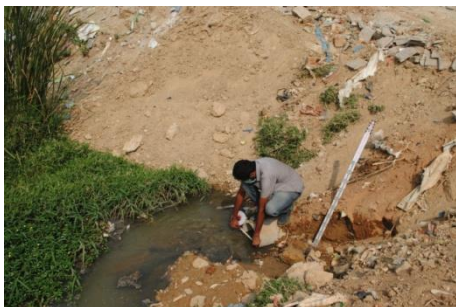
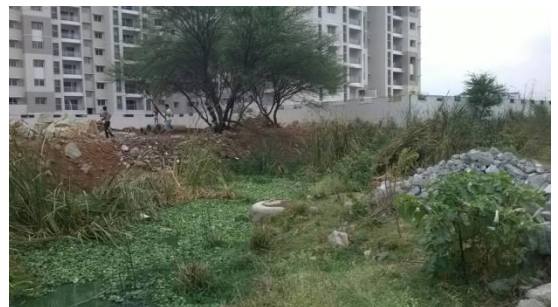
Discharge in a partially full circular culvert

Pipe diameter	Flow depth	Bottom slope
<i>m</i>	<i>m</i>	<i>m/m</i>
0.30	0.10	0.0001

Water Area	0.152198
Velocity Reading 1	0.66 m/s
Velocity Reading 1	0.63 m/s
Flow Estimate 1	5.6MLD
Flow Estimate 2	5.4MLD

Total daily discharge volume	236.71
Total daily discharge volume	0.24

Daily discharge volume 236 m³
0.24 mld

Daily discharge volume 5396 m³
5.4 MLD

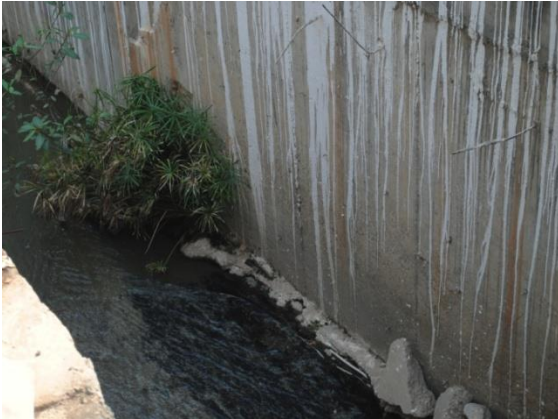
The flow at Kempapura was estimated using the float method, because the stage was very low. The stream was also not accessible as it had steep sides.

A correction factor was applied to convert surficial flow velocity to average velocity.

Time (s)	Distance (m)	v (m/s)
			0.8361204
Times (5 m)	5.98	5	01
			0.9416195
	5.31	5	86
	5	5	1
Stage	0.03 m		
Section width	2 m		(Rectangular drain)
Cross sectional area	0.06 sq m		
Flow rate 1	0.05017 m ³ /s		
Flow rate 2	0.05650 m ³ /s		
Flow rate 3	0.06000 m ³ /s		
Correction Factor	0.65		
No of seconds/day	86400		
Flow rate 1	2817	m ³ /day	2.8 MLD
Flow rate 2	3173	m ³ /day	3.2 MLD
Flow rate 3	3370	m ³ /day	3.4 MLD

The flow at Kempapura drain was estimated to be 3.2 MLD.
